CARTER MANUFACTURING CO., INC.
 GRAND HAVEN, MICHIGAN 49417

PART NAME: ASSEMBLY

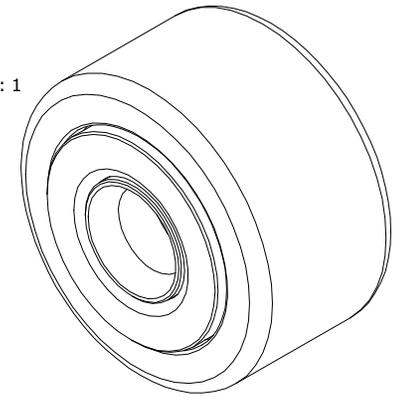
ISO VIEW
 SCALE 1.625 : 1

MATERIAL NOTES:
 OUTER RING - BEARING STEEL, HEAT TREATED
 INNER RING - BEARING STEEL, ZONE HARDENED
 BUSHING - SINTERED BRONZE
 WASHER(S) - BEARING STEEL, HEAT TREATED

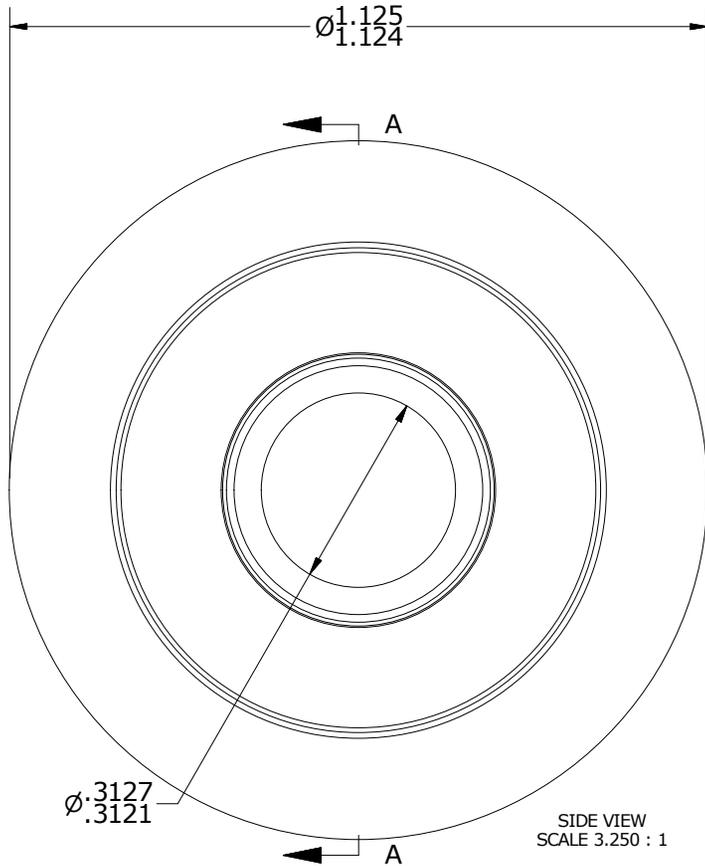
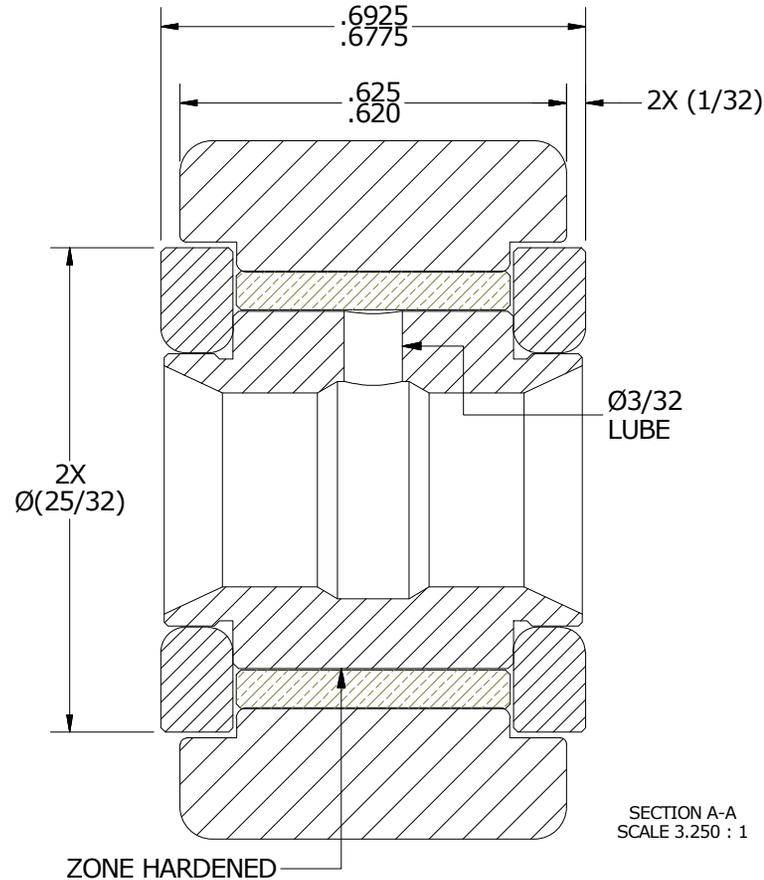
- NOTES:
 1. BUSHING IS IMPREGNATED WITH OIL
 2. ALL EXPOSED STEEL SURFACES HAVE BLACK OXIDE
